# spillage goes up with depressurization

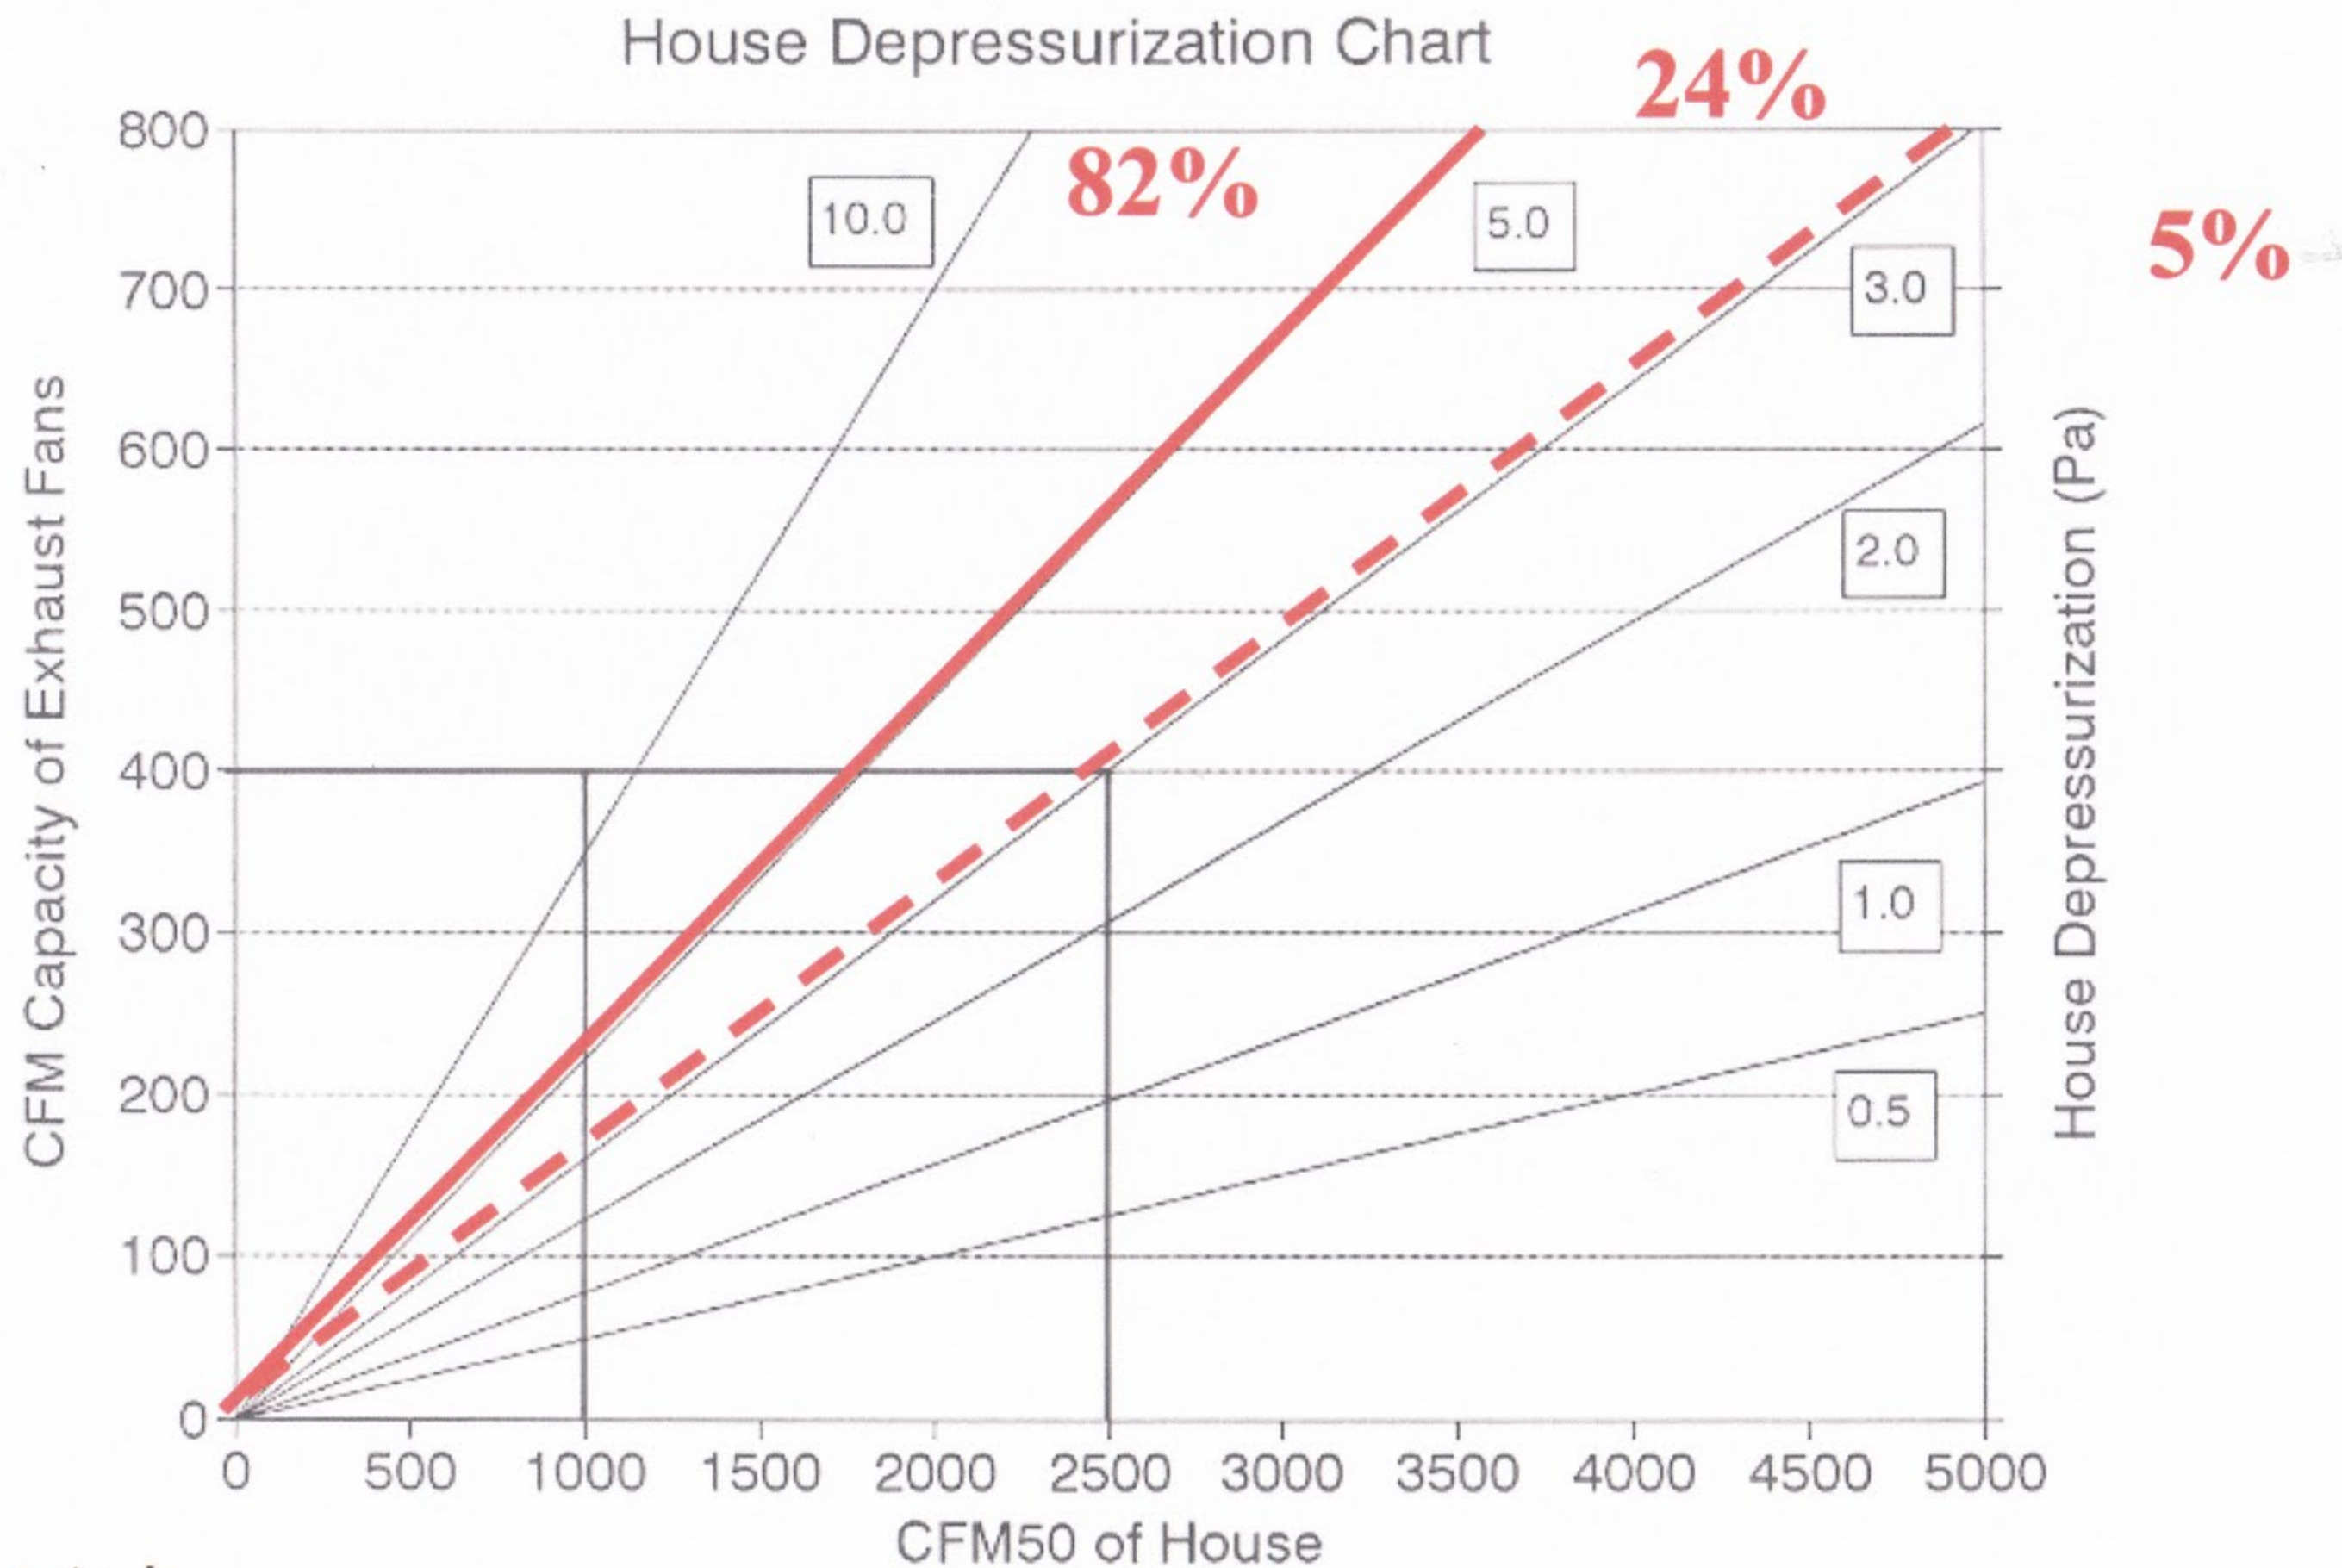
From 1075 tests in  
Mpls Sound Program
